# **BUILDING INSPECTION REPORT**

**Ravensthorpe Kindergarten**

**Daw St Ravensthorpe WA 6346.**

Site visit for Inspection carried out on 20-05-2010.

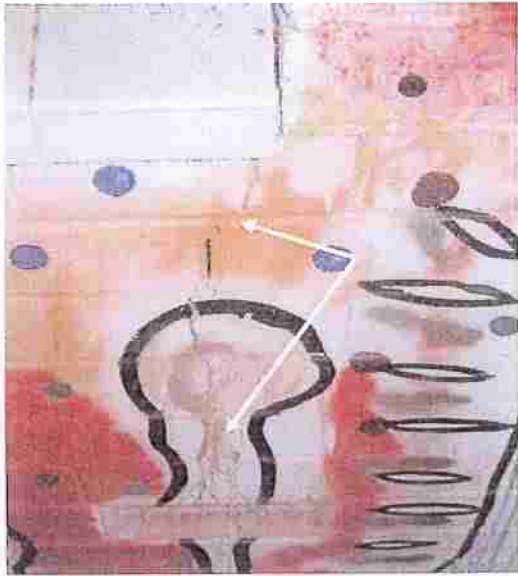
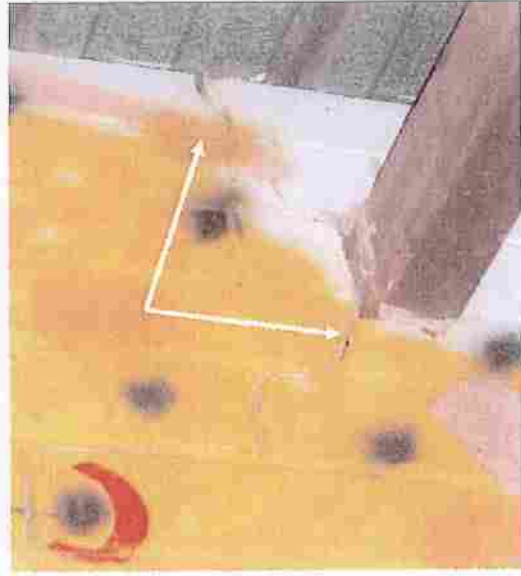
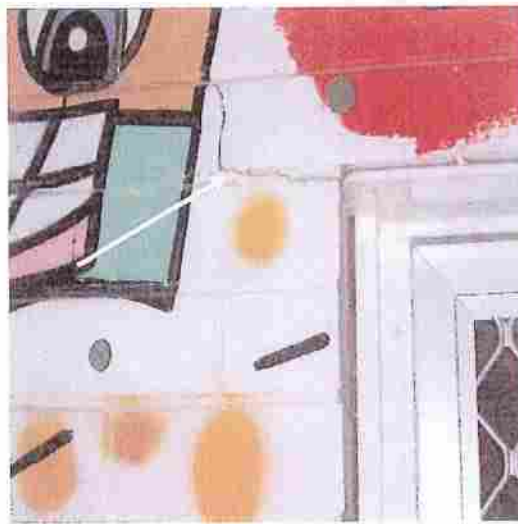
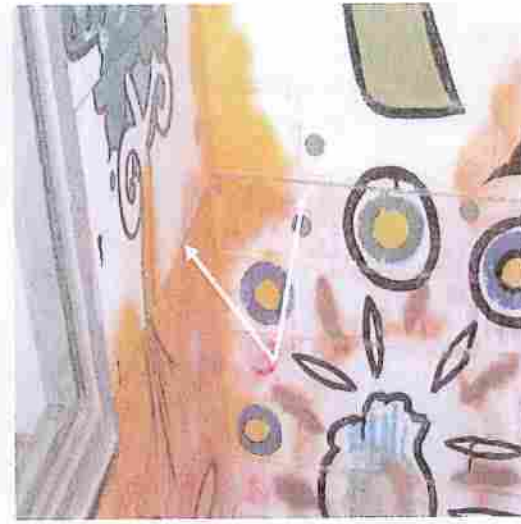
It is apparent that the building was having serious structural problems due to the reactive nature of the site and insufficient ground works. Other works were commissioned to try to rectify any further damage. The new additions in 1985-85 were of timber frame construction with gyprock lining internally & Hardi-Plank lining externally. Some brickwork was demolished and replaced with new timber framed walls & Hardi-Plank lined walls.

Visible cracks in Brickwork outside the building.

The most practical solution & cost effective way to carry on the purpose of the reserve would be to demolish the building and re-build/ re-develop on one side of the lot.

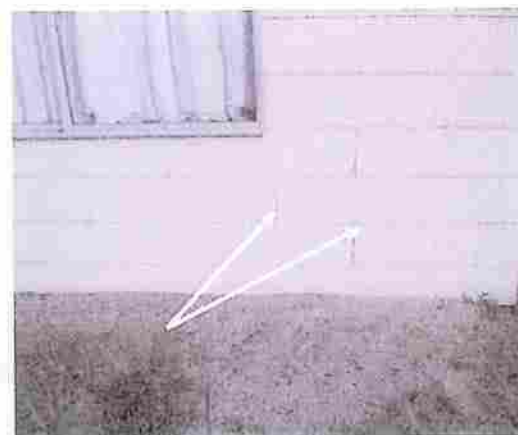
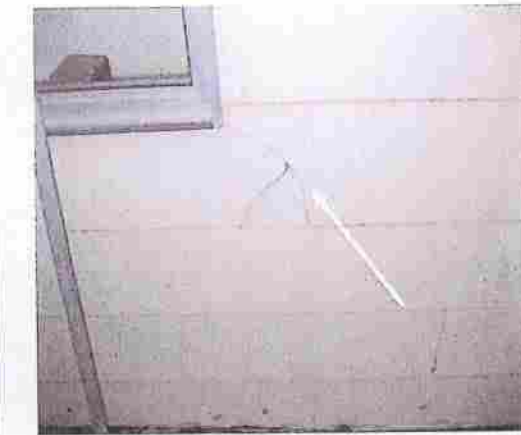
Cracks in External Hardi-Plank Wall Lining

Wall Cladding	<p>Plain Hardi-Plank. All in a very poor condition. Many sheets are cracked &amp; need replacing.</p>
Type & Condition	<p>Cream</p>
Colour	<p>Paintwork is in a very poor state</p>
Painting	<p>Fair</p>
Fixings	<p>Generally all framed walls appear reasonably true &amp; plumb.</p>
Wall Frame	<p>Generally all framed walls appear reasonably true &amp; plumb.</p>

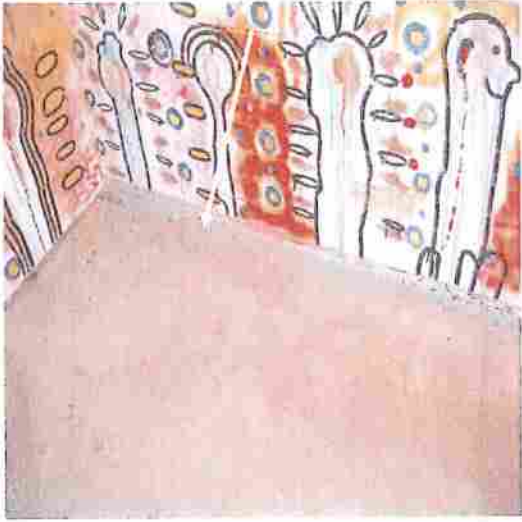
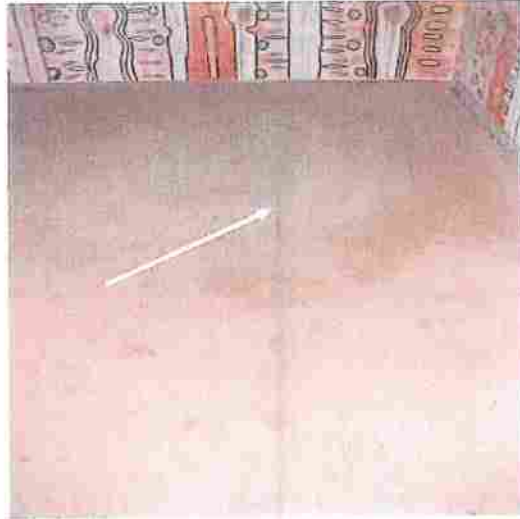
Front Verandah Concrete Floor Cracks & Subsidence.

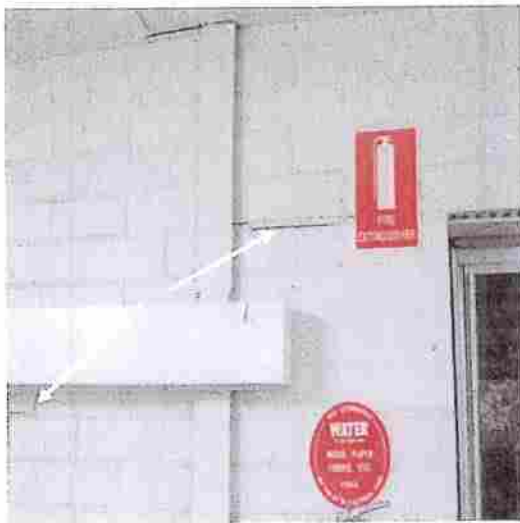
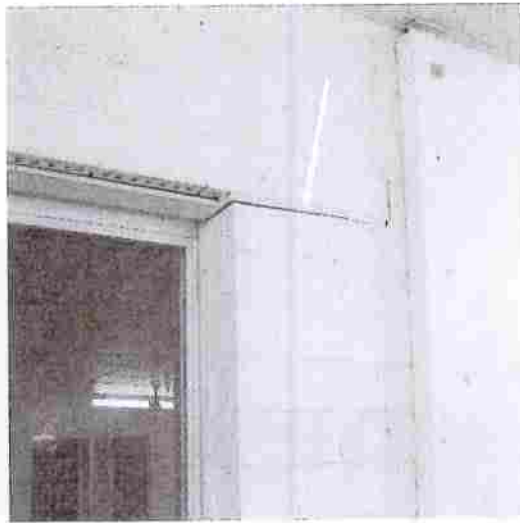
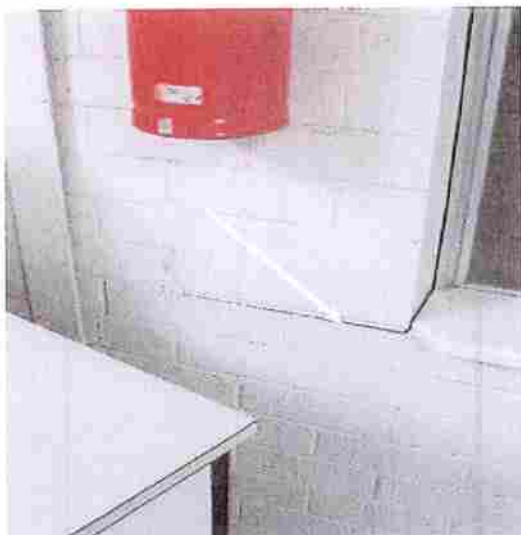
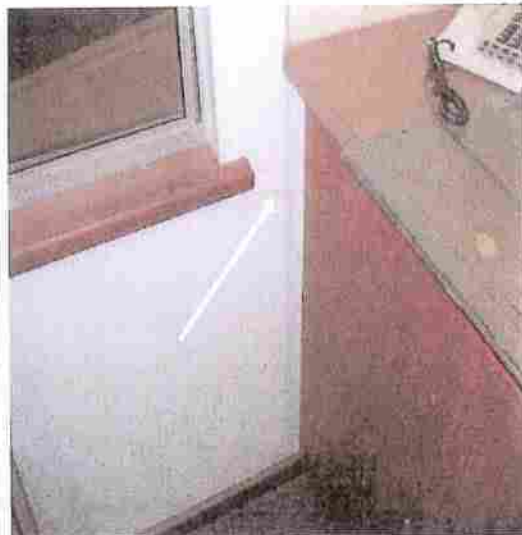
Bad Cracks in Brickwork Inside

Walls  
Painted standard brickwork. Shows signs of SERIOUS cracking adjacent to doorframe & front window

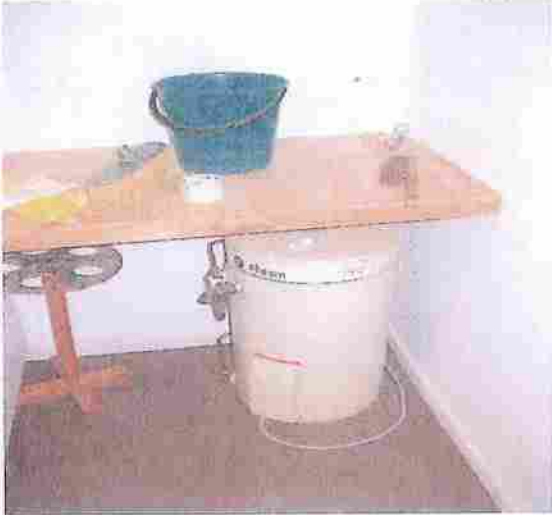
HWS in Storeroom

HWS	COMMENT
LPG Gas	N/A
Electric Storage	Rheem 50L looks to be in fair condition. As the power point is not working the HWS was unable to be tested.
Solar	N/A
Tempering Valves	Nil. There should be a tempering valve fitted to the HWS by law.
Hot+Cold Relief Valves	Hot working Cold needs servicing
<b>Insulation</b>	
Ceiling	No evidence of insulation.
Roof	Unable to determine
Walls	Unable to determine
<b>Work Area</b>	
Floor Covering	Vinyl clean & in fair condition
Walls	Painted brick on the main walls & small partition walls are gyprock/fibro clad topped with a varnished wooden top.
Ceiling	Common with main hall area suspended asbestos flat painted panels. Needs changing.
Skirting	Some black standard vinyl & some timber all in reasonable condition.
Architraves	Solid varnished timber needs re coating
Lights & Switches	This room has a common ceiling through the main entry/work/play & kitchen area all w/- fluoro lighting

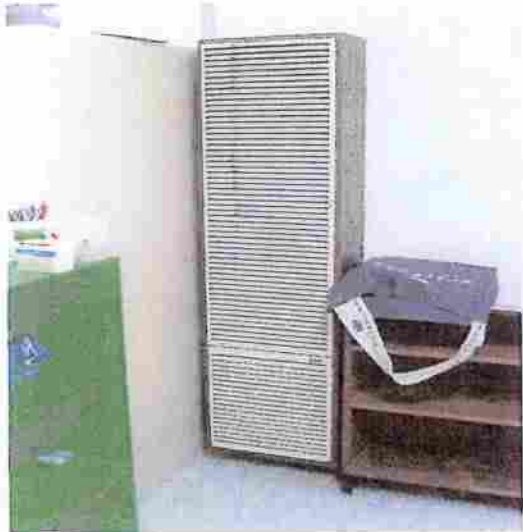
Old Gas Room Heater

Window Sill	Painted timber needs repaint/varnish.
Heating	Adjacent to the kitchen on the back wall inside the main room is an old gas heater. This should be removed.
Air Conditioner	There is evidence of a once existing split system on the back wall. This has been removed and the circuit breaker in the internal electrical sub-board has been tagged out. I have instructed P Rothnie to disconnect the power to this circuit in the back of the sub-board.
Fire Extinguishers	
Location	One 9kg BCF adjacent to the dbl front entrance doors. One 2kg BCF & a fire blanket in the kitchen area
Date Due For Service	September 2010

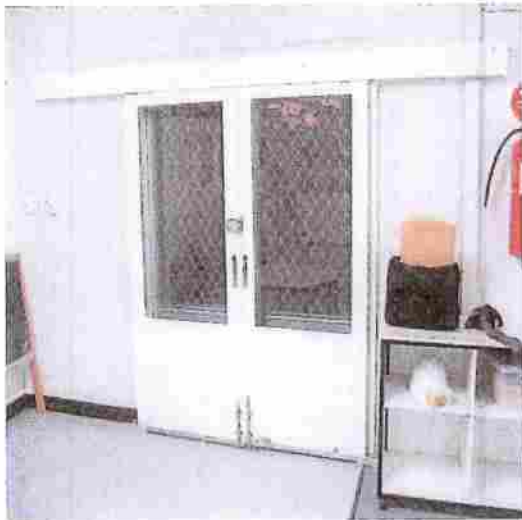
Main Doors are Unsuitable Sliders

Sliding Door Track  
Operational but very inefficient. Need to adjust doors on sliding overhead track to close properly

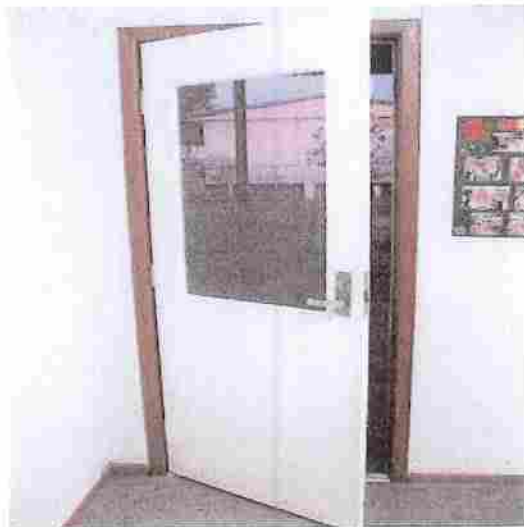
East Exit Door

Power Points	A few doubles scattered throughout at various heights.
Door & Hinges	Eastern side entrance door is a timber half panel clear glass hinged door needs repaint
Door Handle	Lockwood lever lock type in fair condition. Key operation OK.
Door Jamb	Painted timber needs repaint/varnish. Door opens in. Query that both lots of entrance doors in a Public building should open out for OSH & FESA standards, BCA?
Crash Bars	Nil
Drop Bolts	N/A
Window Glass	All aluminium windows in the main hall section of the building have clear glass. All glass is in good order i.e. no cracked panels visible. Some of the rollers are stiff & all could do with tracks cleaned out
Window Locks	Most appear ok but all require some minor maintenance.
Flywire	Some flyscreens are non existent. Some need repair & flywire replaced where holes are prevalent.
Window Reveals	Some are plain painted brick, some are either painted or varnished timber, others flushed gyprock all require some painting or minor repair.

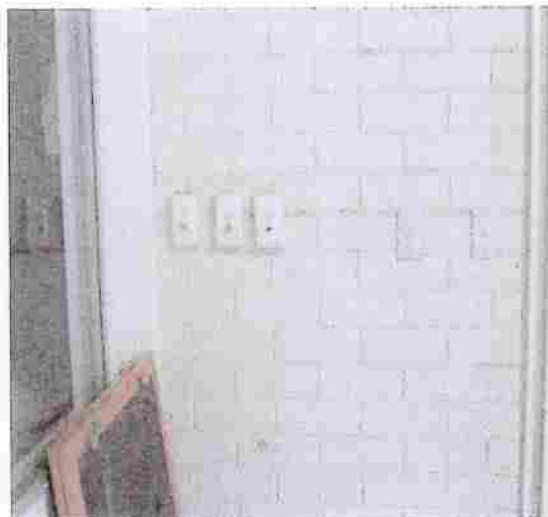
Ceiling Fan Controllers

Ceiling Fans  
Total of 5 throughout main ceiling. Controllers at Main entry doors inside. None were operational

and part of the speed controller knob was missing on one of the units. Fans appear to be in fair

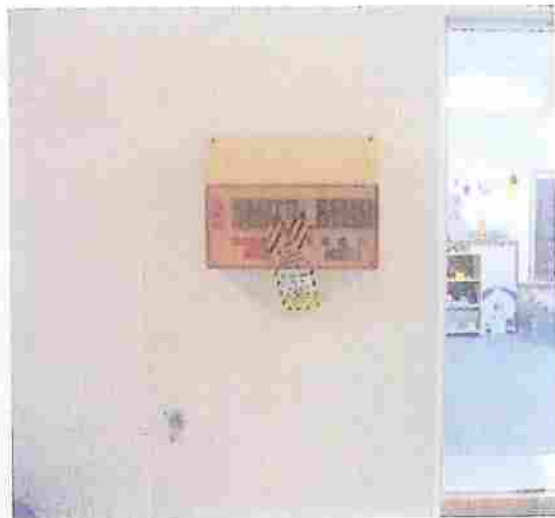
Electrical Sub-Board Tagged Out

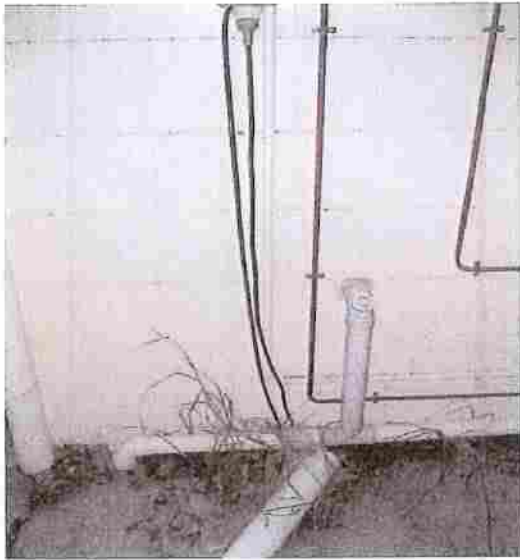
It is still in the original location today. I am led to believe though, that for quite some time it has not been operating properly as the sump was full of Kikuyu grass on the day of my inspection. I removed the grass & roots that were stopping the pump from operating as it should be. The pump then began to draw water from the sump and pump it out to?? Its connection method. to the external power point. is highly illegal.

Cables to Pump outside.

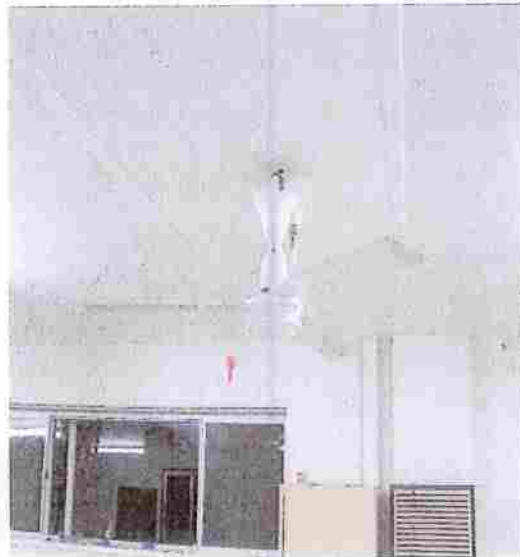
Ceiling Fan. Painted Asbestos ceiling.

Ceiling  
Suspended painted asbestos flat sheet. Looks in ok condition. Should be professionally removed.

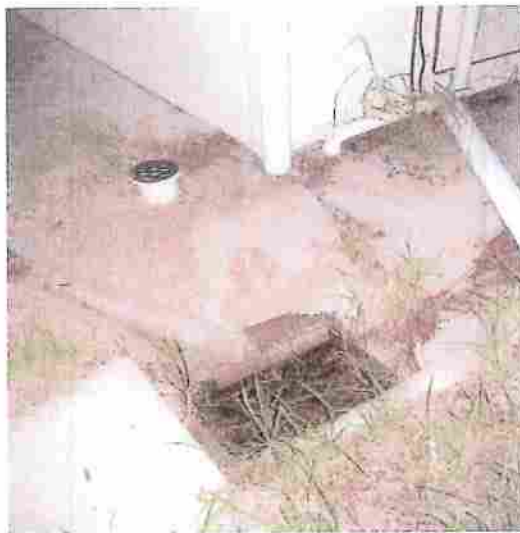
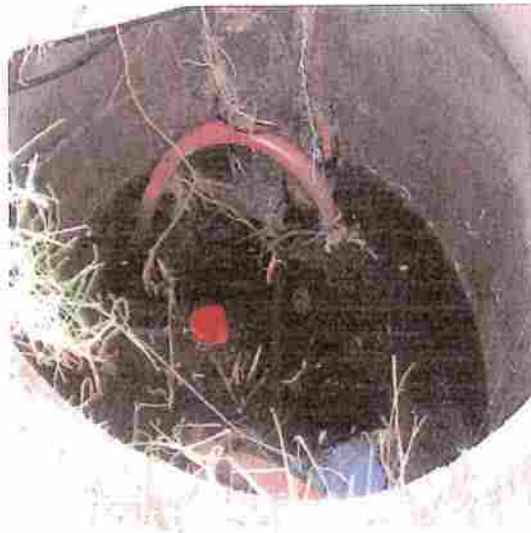
Stormwater "Pit" Cracked Concrete with Weed Infestation to Sump

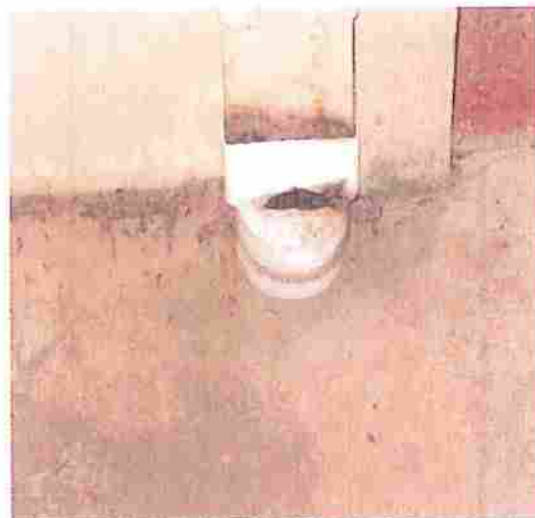
Stormwater Pipe Fitting Leaking

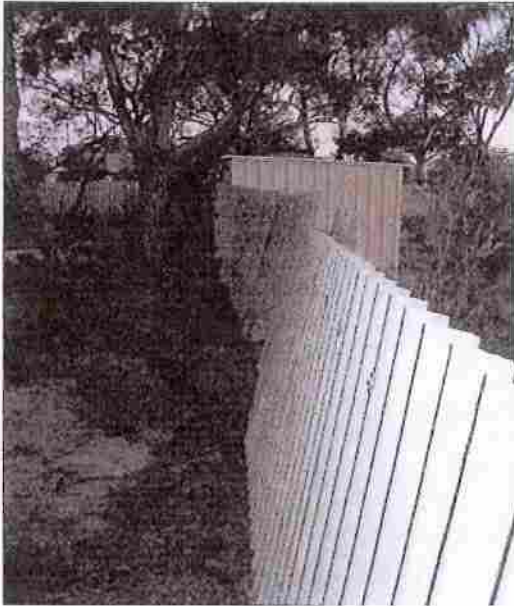
Asbestos Division Fence

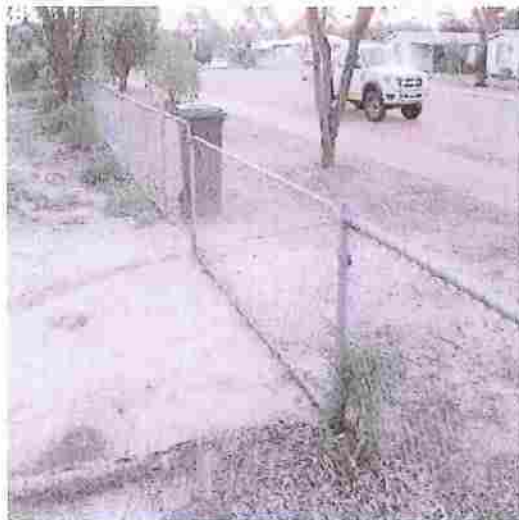
Main Front Fence No Parking

Parking	COMMENT
Location	Currently the users of the facility have no onsite parking. Vehicles are parked on the verge adjacent to the council footpath. This is extremely dangerous considering the use of the building for children.
Paving	
Type & Size	600 mm x 600 mm concrete slab. Basic amount on the east side & from the front entrance gate to the front verandah.
Weeding	Required
Sinking	Pull up and relay
Missing	N/A
Border Cemented	N/A
Trafficable	Yes
Paths	Concrete paths to rear play area to access shed etc.
	Other concrete to the rear and west side of the building forming drainage for stormwater is in disrepair. Some is severely cracked and has allowed the ingress of Kikuyu grass into the effluent drainage piping causing a recent grey waste water blockage. I have asked the G Sutherland from our Town crew to spray the grass etc at this location.
Retaining Walls	
Type & Height	Concrete Approx 500 mm high.

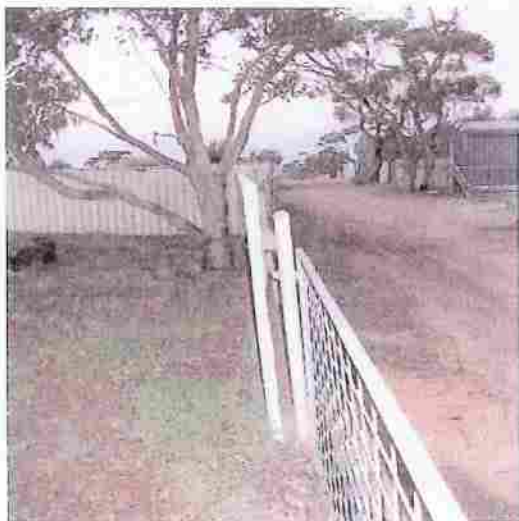
Rear Fence Leaning Over

Boundary Fencing		COMMENT
Location		Rear. The eastern most lot has a rear fence Approx 1.2 M high. The west lot has no rear fence to the lane
Type		Hardi-Fence Super Six profile could be asbestos.
Condition		Poor
Gates & Latches		One central, in fair condition, to allow for vehicle access.
<b>Internal Fencing</b>		
Location	Central Division Fence	Western Side Division Fence
Type	Approx 1.8 m high from back of building to rear lane. Super Six profile all <b>asbestos</b> on timber posts & rails.	Approx 1.0 M High from west side to boundary Steel pipe post & rails Cyclone diamond mesh.
Condition	Very Poor posts broken off and bad lean on sheets.	Poor pipe is rusty, gate hinges need adjustment Personnel gate to rear of this lot is ok.
Gates & Latches	N/A	
<b>Front Grounds</b>		
Lawn		Basic Kikuyu & clay sandy soil
Reticulation		Nil
Condition		Very Poor condition, basically non-existent very untidy and not maintained.

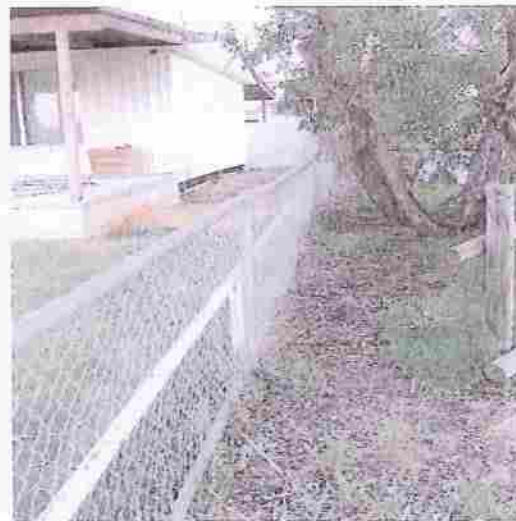
Front Portion of Eastern Fence

<b>Boundary Fencing</b>	
Location	<b>East Side.</b> 20 M Approx 900 mm high. The remaining towards the rear of the lot is @ 1.2 M high
Type	Front first @ 20M is Steel pipe post & rails with Cyclone diamond mesh. The remainder is post & rail Hardi Super Six
Condition	Steel fence good. Hardi fence poor.
Gates & Latches	N/A
